Evaluating the Effect of Manufacturing Porcine Epidemic Diarrhea Virus (PEDV)-Contaminated Feed on Subsequent Feed Mill Environmental Surface Contamination¹

L. L. Schumacher², R. A. Cochran³, C. E. Evans³, J. R. Kalivoda³, J. C. Woodworth, C. R. Stark³, C. K. Jones³, R. G. Main⁴, J. Zhang⁴, S. S. Dritz², and P. C. Gauger⁴

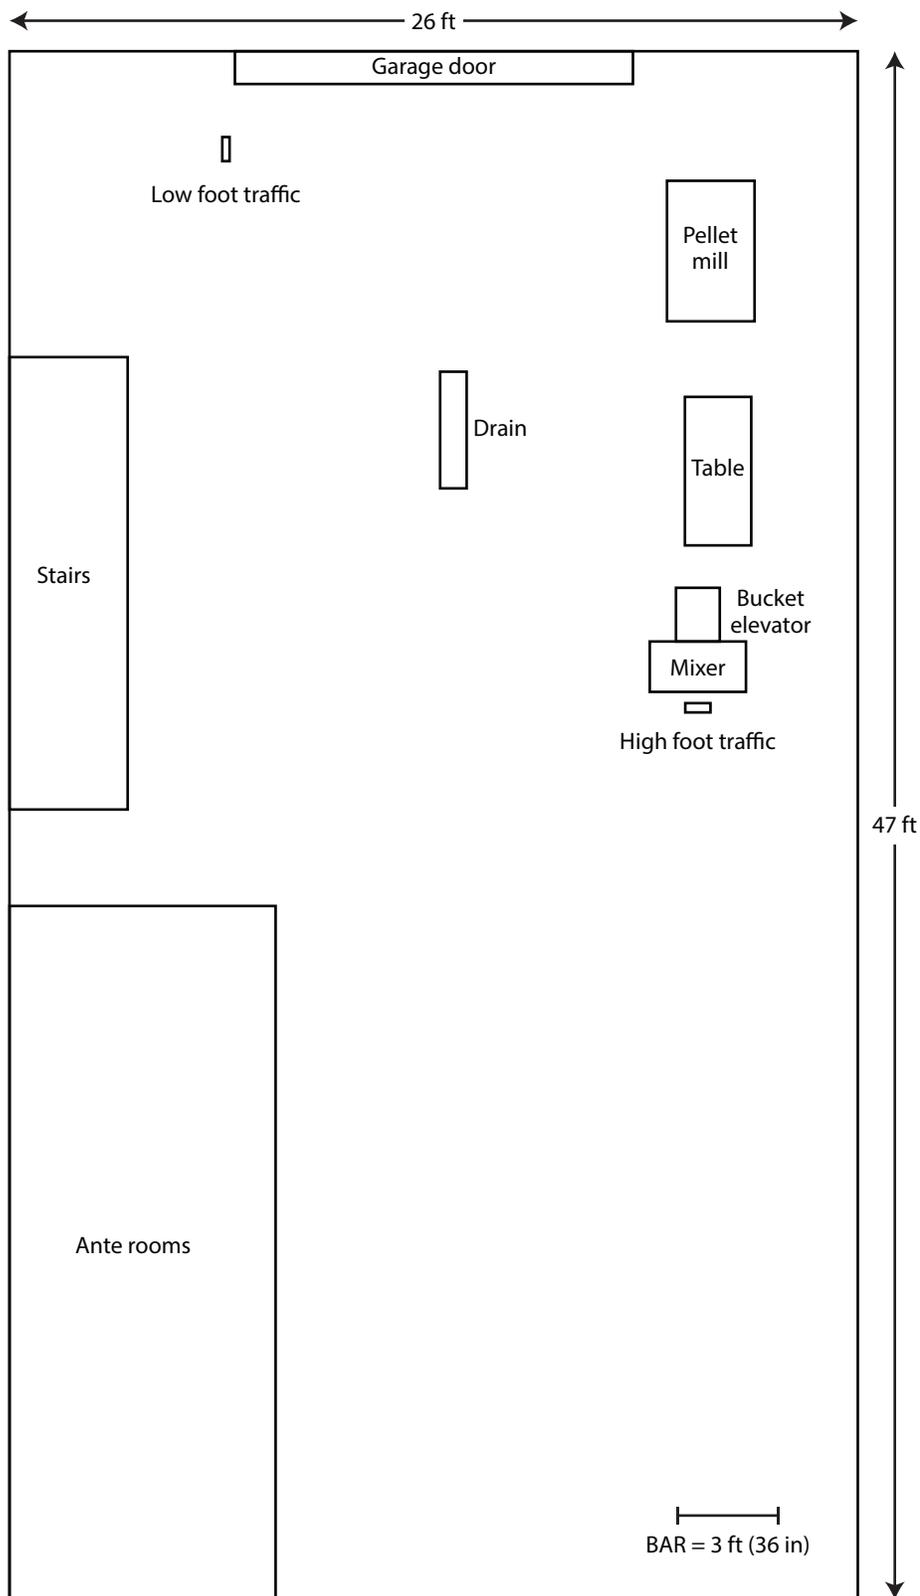
Figure 1. Arrangement of the first floor of the Kansas State University Cargill Feed Safety Research Center. Designated areas swabbed for PEDV PCR analysis include high and low foot traffic areas, drain, garage door, pellet mill, table ledge, bucket elevator, and feed mixer as well as rubber boot bottoms.

The same large foam tipped swabs used for the baseline PEDV-determination were also used to swab designated locations after discharge of the negative control, positive control, and Sequences 1 through 4 for each replicate. Swabs were categorized by sampled material or type of environmental surface from specific locations (Figure 1). Briefly, concrete surfaces included a floor drain, high foot traffic, and low foot traffic area. Metal surfaces included a vertical garage door surface and horizontal table ledge. A rubber surface was the bottom tread of a boot worn during the experiment. Equipment surfaces included metal feed mixer paddles, metal mixer bottom, metal interior of the mixer lid, plastic interior of a bucket elevator, and the rubber bucket elevator belt adjacent to sampled buckets. After completion of Sequence 4 and after pelleting the positive batch, the pellet mill was allowed to cool, disassembled, and swabs were collected at the metal interior of the pellet mill hopper, metal interior of the mash conditioner, metal feeder screw, metal die interior rim, and metal die exterior shroud. All swabs were again collected from the same designated surfaces after physical cleaning, and the two steps of chemical cleaning, and heat-up.

The environmental swabbing sampling areas were outlined in heat-stable marker when possible to form five subsampled areas. Subsampled areas within a location were equal in size; however, the areas ranged from approximately 2.3 in² to 6.5 in² between locations. Subsampled areas within location were randomly allocated to be sampled after the negative control, positive control, and Sequence 1 to 4 feed treatments were manufactured. Thus, one subsampled area was swabbed per treatment and no subsampled area was sampled twice during each replication. Prior to the manufacturing of the negative control and after step two of chemical cleaning and heat-up, the entire surface of all five areas were swabbed to establish and confirm baseline levels.
