## PROTECT STREAMBANKS WITH TREES

W.A. Geyer, T. Neppl, and K. Brooks\*

SRL 122

October 1998

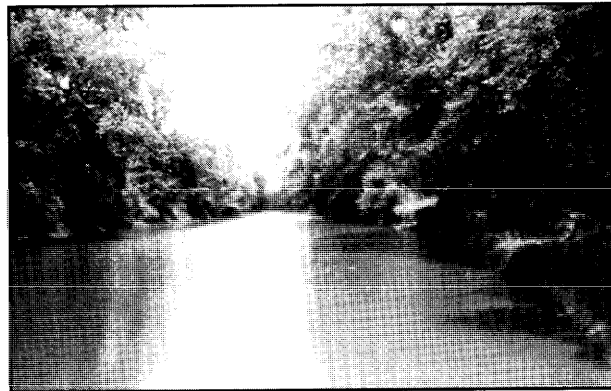
**Figure 4. Natural woody vegetation should be left to protect streambanks.**
